*Failed Bridges*

*Case Studies, Causes and Consequences*

Author: Joachim Scheer

## 11.2 Failure due to inadequate lateral stiffness

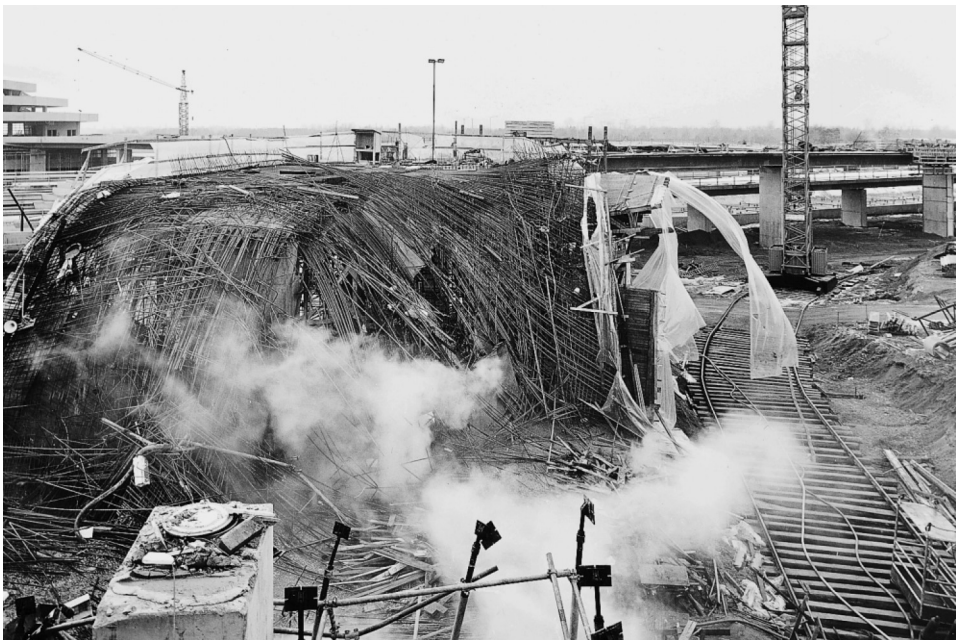
One example is the scaffolding for a bridge ramp at Cologne-Wahn airport, 1995, Case 11.45. The report [103] states that a number of errors contributed to the accident besides the lack of adequate bracing for the steel tubes butted together as props. The last approx. 50 m long section of the exit ramp was under construction when a serious accident occurred (Fig. 11.1). Steel shoring, consisting of swivelling head plates on spindles, extension tubes, standards, base plates and steel scaffold fittings, had been erected to support the formwork for the elevated reinforced concrete T-beam slab . . . Concreting work had got to the stage of the pouring and compacting of the wet concrete in the last third of the ramp when suddenly and without warning a 30 m section of the scaffolding collapsed. Not only was there a huge 750 t pile of concrete, steel and timber, but the heaters installed to produce warm air during the winter also toppled over, the heating oil leaked out and started a fire. Members of the concreting gang slid with the mass of concrete from a height of 10 m. Some workmen succeeded in

Fig. 11.1 Collapse of supporting scaffolding for a bridge ramp at Cologne-Wahn airport. 1995, Case 11.45

The inquiry was unable to explain the cause of the accident conclusively but the following deficiencies were found:

- General type approval certificates could not be produced for all scaffolding components.
- The scaffolding work was extremely defective, for example short tubes had often been joined together many times to form standards.
- Bracing connections were completely missing at some points. The upper horizontal bracing had often been joined to the thread of the spindles instead of to the extension tube, compensating the difference of diameter with wooden wedges.
- In some cases the scaffold couplings were not even closed.
- Due to a setting out error, the scaffolding had first been constructed too high and had to be corrected. This had been achieved using makeshift supports and wedges.
- Pin-ended columns were frequently not axially loaded.
- Some standards had simply been placed on the ground without base plates.

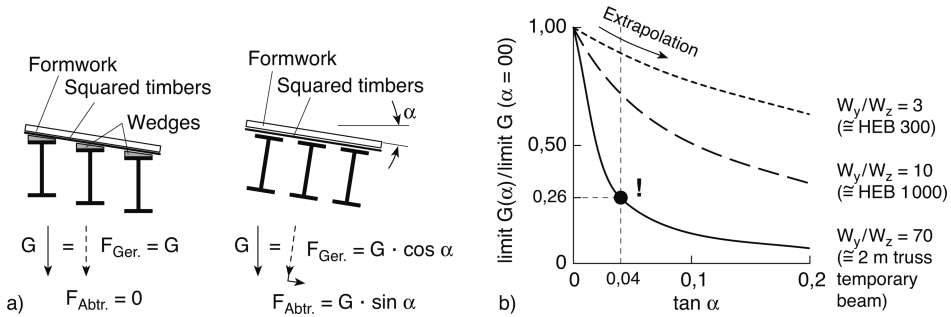
The bridge had a relatively high transverse cross-fall of  $\alpha = \text{approx. } 4\%$ . If the slab formwork had been placed on scaffolding with vertical temporary beams (Fig. 11.3a, left), wedges would have been necessary at each junction between beams and squared timbers - over 1000 wedges for the entire bridge. The temporary trusses would only have been stressed by the weight load (G) along their main axes (z). To reduce the work of the shuttering carpenters it was decided, as on other occasions for scaffolding with a shorter span but also using rolled-

Fig. 11.3 Collapse of scaffolding for a road bridge over the River Leubas near Kempten. 1974, Case 11.24  
 a) 2 possible scaffolding details for bridges with a crossfall  
 b) limitation of the load-bearing capacity  $G(\alpha)$  by angle  $\alpha$ , related to  $G(\alpha=0)$

steel beams, to slope the beams with the same cross-fall as the slab formwork (Fig. 11.3a, right). The horizontal force component resulting from the weight of beams, formwork, reinforcement and concrete is therefore  $F_{\text{Abr.}} = G \cdot \sin \alpha$  at right angles to the axis of the web. The scaffolding designers failed, however, to assign this to the wind bracing = stabilization bracing. They rather assumed, without checking, as an extrapolation from previous scaffolding experience that this component would be absorbed by transverse bending in the beams without serious consequences for the structural safety of the scaffolding system. This past experience had been with smaller transverse gradients and rolled-steel beams with a relatively low ratio of the two resistance moments  $W_y/W_z = \text{approx. } 3$ . Transverse bending had only had a relatively small influence on structural safety (Fig. 11.3b). There were two important differences in the scaffolding for the Leubas bridge:

- the highly “stretched“, approx. 2 m high truss beams had a much higher ratio of section modulus:  $W_y/W_z = \text{approx. } 70$  ( $W_y$  of the upper chord) and
- the cross-fall  $\alpha$  of approx. 4% was extremely high.

Fig. 11.3b makes these correlations clear. It shows 3  $W_y/W_z$  ratios against the tangent of the angle of inclination  $\alpha$  to the limit load  $\text{limit } G(\alpha)$  for the inclined temporary beam to the limit value  $\text{limit } G(\alpha=0)$  for the vertical beam.

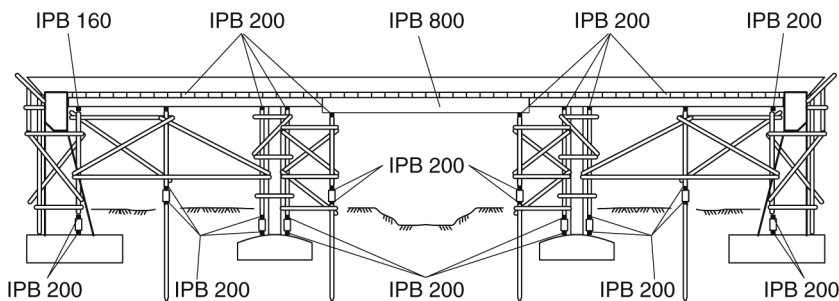
The drawing in Fig. 11.4 is taken from [5, p. 25]. It shows the scaffolding built of steel IPB beams on timber props. Between the towers standing on the foundations of the bridge piers and the abutment, there was an arrangement of single-walled intermediate trestles supported on timber piles. IPB 200 beams were located above and below the spindles on the baseplates. There was no bracing over a height of 1.3 m, nor across the longitudinal axis of the bridge. Some of the wooden piles projected more than 1 m out of the ground and were not braced. The collapse occurred in the middle of the main span which was bridged with IPB 800 temporary beams and held only by single-walled intermediate trestles.

The report [5] cites a large number of further deficits: reckless intermediate timber constructions between longitudinal and frame beams; the frame beams were not infilled under the longitudinal beams although concentrated loads of up to 300 kN were introduced; there was nothing to prevent the longitudinal beams from tipping; bracings had not been fitted although required in the drawings from the supervisory engineer and the connections of the round timber members of the bracings were faulty.

Fig. 11.4 Elevation of scaffolding for the Wallenhorst railway overbridge. 1966, Case 11.9

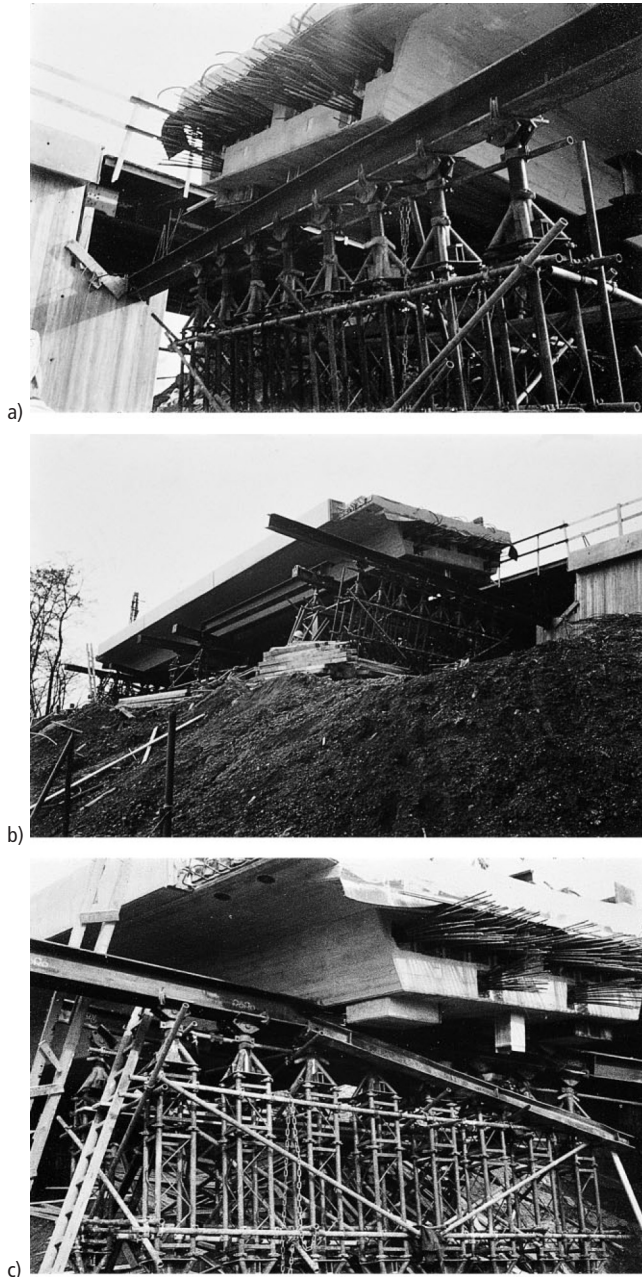
Fig. 11.6 shows the site after the collapse: (11.6b) gives a general view while Fig. 11.6a shows the north side and 11.6c the south. It can be seen that the distribution beams have fallen out and the superstructure is resting on the jacking beams.

**Fig. 11.6** Scene of partial collapse of a railway bridge between Solingen and Ohligs during sideways jacking, 1977, Case 11.29

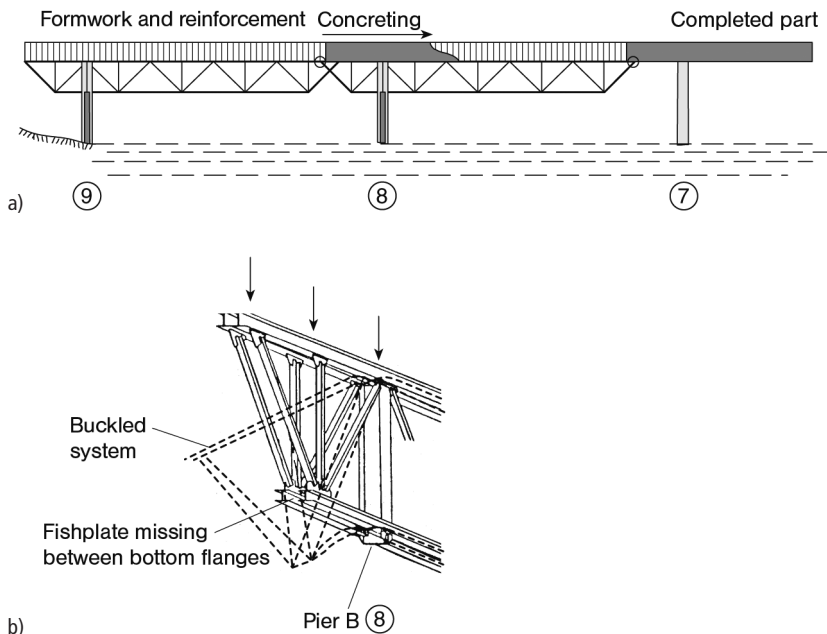
The scaffolding failed shortly after concreting had reached the support cross section. It began with lateral deformation of the bottom chords of one of the two truss beam pairs in the cantilever section (Fig. 11.7b) followed by the entire cantilever section of the concreting beam, which then caused the collapse of the formwork beam. According to reports, the entire collapse lasted about 15 minutes.

The structural analysis had assumed that the two bottom chords of each pair were held together at the tip of the cantilever by a horizontal gusset plate. But this gusset plate had

Fig. 11.7 Scaffolding for an express highway in Sweden, Case 11.48

been forgotten in the drawings. The truss became unstable in the area of the 1<sup>st</sup> bottom chord node with 3 compression members and 1 tension member in each truss wall and buckled.

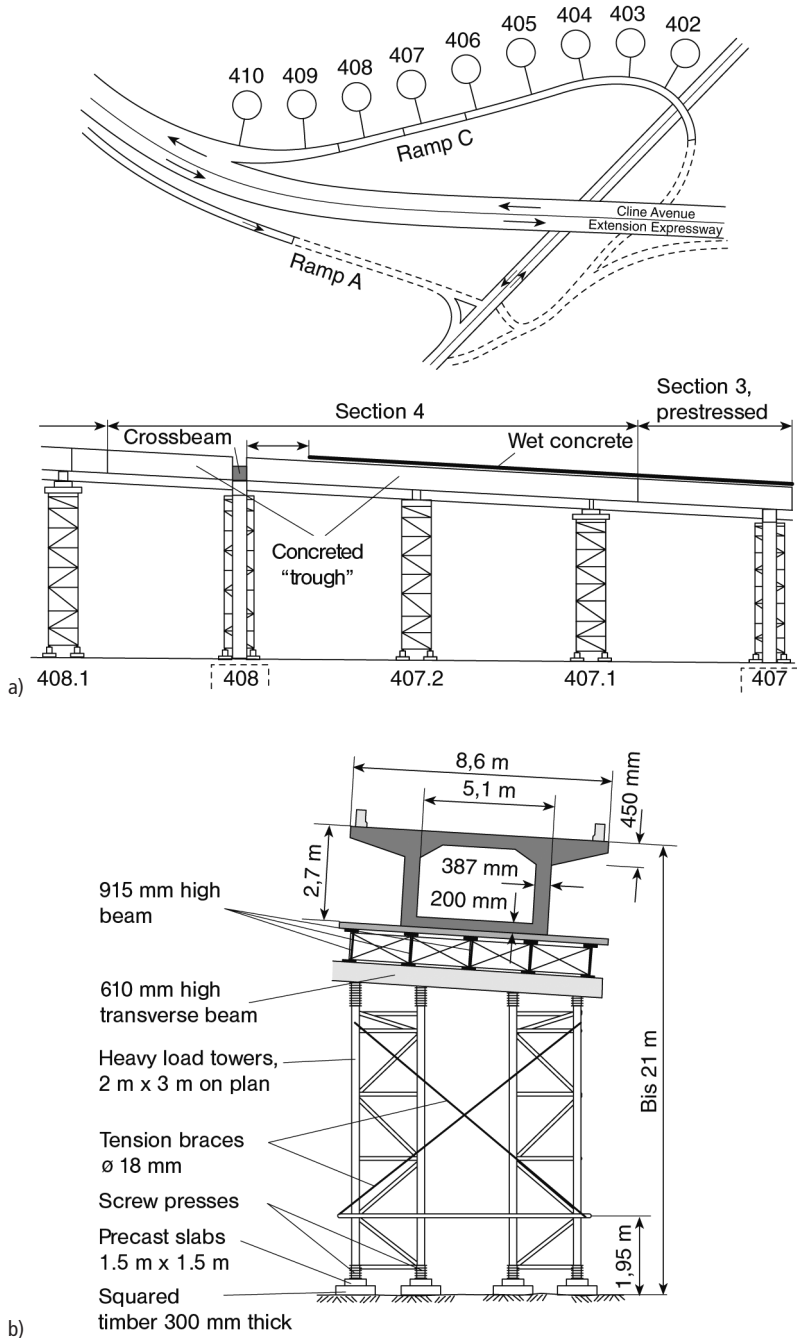
The ramp needed to connect a ground level road with an express freeway required a multi-span bridge first curved in the horizontal plane and then running in a virtually straight line (Fig. 11.9a). It was built as a prestressed concrete single cell box beam (see Fig. 11.9b for dimensions) with spans of up to approx. 55 m. According to reports the longitudinal gradient was up to 3.6 % with – as can be seen in Fig. 11.9b – a transverse gradient of up to approx. 3 %.

The foundations of the support towers at the third points were precast concrete slabs, 1.5 m x 1.5 m. Contrary to the design, these were 300 mm instead of 530 mm thick. 30 cm thick squared timbers were to be placed between the concrete slabs and the baseplates of the support towers for load distribution (Fig. 11.9b).

The ground beneath the slabs had neither been analyzed nor prepared for scaffolding although the top 1.5 to 2.7 m consisted of a fill of ashes, cinders and sand “with an oily smell”. In some areas compressible black organic mud had also been found. Soil compaction, according to the plan, must have been around 155 kN/m<sup>2</sup>.

The cantilever bridge section over support 407 was completed and prestressed. The trough and the transverse bearing beam over support 408 had been concreted for the section projecting over support 408 (Fig. 11.9a). The trough was already in place for the further sections up to the end of the bridge for connection 410 to the freeway. Work was in progress to concrete the road deck from the end of the cantilever arm in front of support 407 in the direction of 408 – upwards due to the longitudinal incline – when the support tower 407.2 collapsed. The fall of the trough and the road deck, which had not yet hardened, from a height of approx.

Fig. 11.9 Scaffolding collapse during construction of a bridge in East Chicago. 1982, Case 11.33
